Stop and Shop and Crystal Springs Plaza

Walk Audit Report

Prepared for the Town of Belchertown by:
Healthy Hampshire/Mass in Motion
Collaborative for Educational Services, Northampton, MA

July 2015

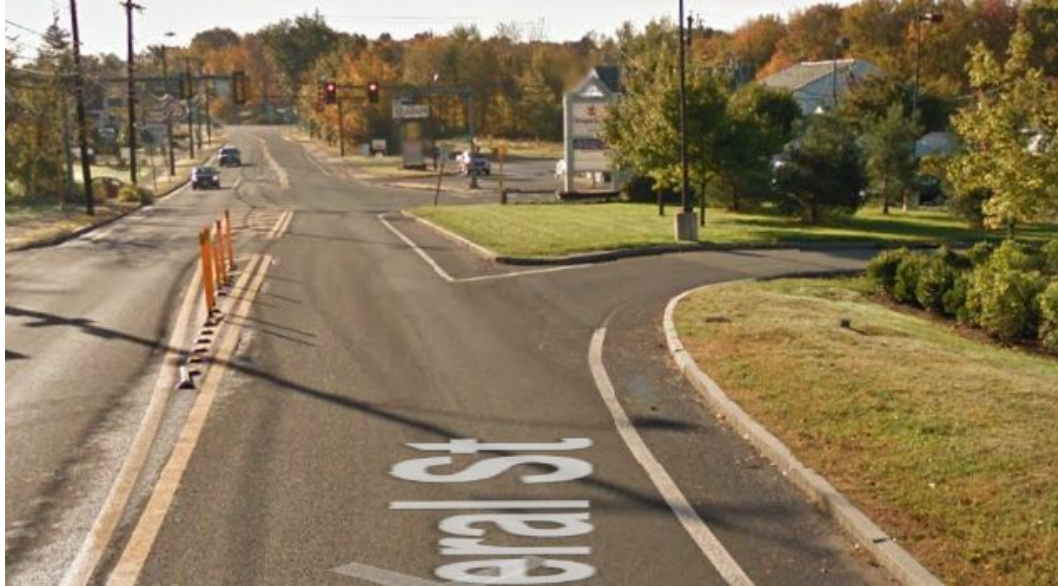
N Heading East on Route 9 (Federal St). Stop and Shop is off to the right.

This is the first intersection with a stoplight that drivers encounter when entering Belchertown. To the right is the Stop and Shop plaza, which includes a bank building and gas station. Drivers may turn right at the light onto George Hannum Road to get to Dana Woods, which is a residential development, and eventually to Jackson Street, where the New England Small Farms Institute and community garden is located. There is a sidewalk on the north side of Federal Street, but not on the south side. Crosswalk design at the intersection is two parallel lines. There is a pedestrian signal at both roads crossing Federal Street and George Hannum Road. Drivers are allowed to go right on red from all directions. The pedestrian light is a hand signal, not a countdown clock. It does not have an audio warning for people who are visually impaired.

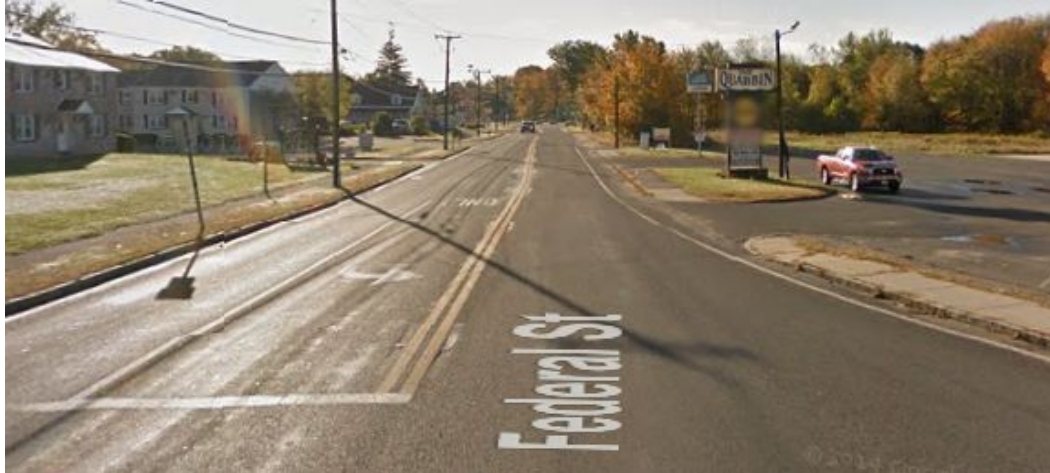
Stretch of Federal Street with Crown Point Apartments

The sidewalk on the south side begins at the intersection. There is no buffer on this side between the sidewalk and the road. The sidewalk continues on the north side and there is a grassy buffer between the sidewalk and the road. There are curb ramps down to the road and crosswalks but they do not have detectable warning strips and markings. The sidewalk crosses several curb cuts in this section of road, including to the Quabbin Shops and the Crown Point Apartments. In both instances the sidewalk does not continue across the curb cut. There is nothing indicating the right of pedestrians to occupy that area. There are two curb cuts for the Quabbin Shops, which may be unnecessary.

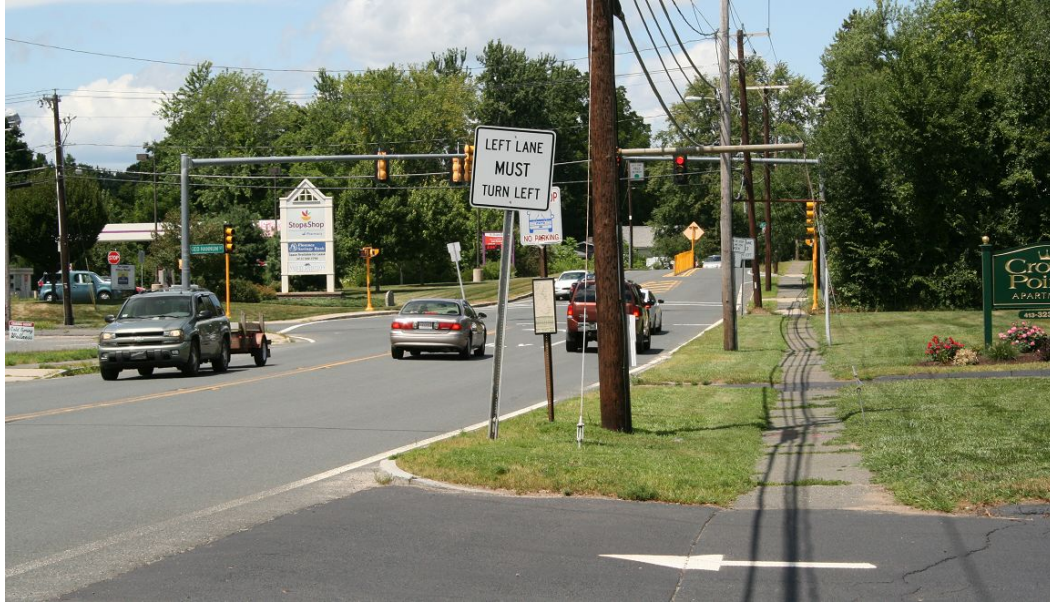
Looking West on Route 9

Opposite the Quabbin Shops are the Crown Point Apartments. There is a bus stop outside of the apartment complex, but the sign is partially hidden by the “Left Lane Must Turn Left” sign.

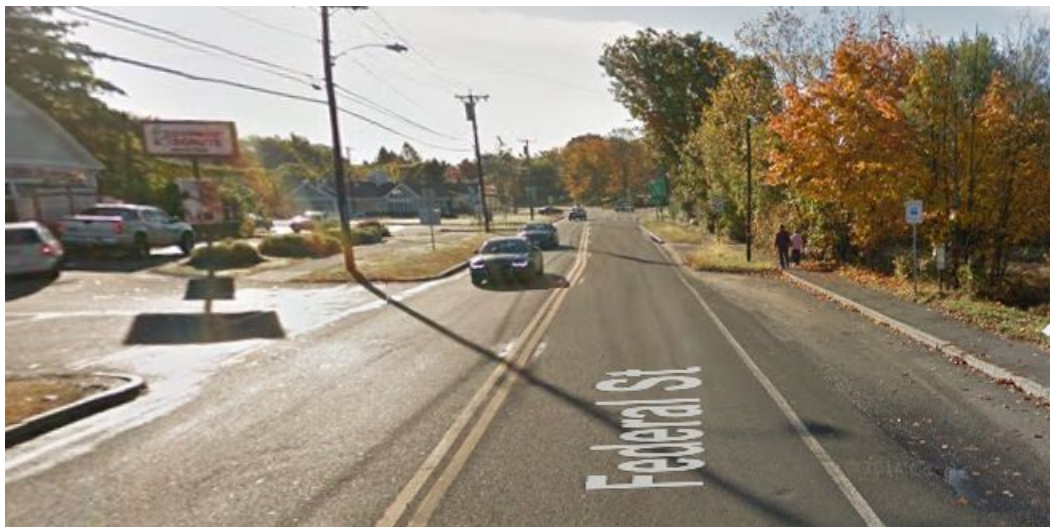
Bus pull off on Federal St.

Farther down Federal Street there is a bus pull off. There is no shelter. On the opposite side there are several businesses that have curb cuts, and the sidewalks are not continuous across those driveways. After the bus stop there develops a grassy buffer between the sidewalk and the road. Just after Dunkin’ Donuts the sidewalk on the north side stops. The sidewalk on the south side continues through the Route 9/Route 202 intersection.

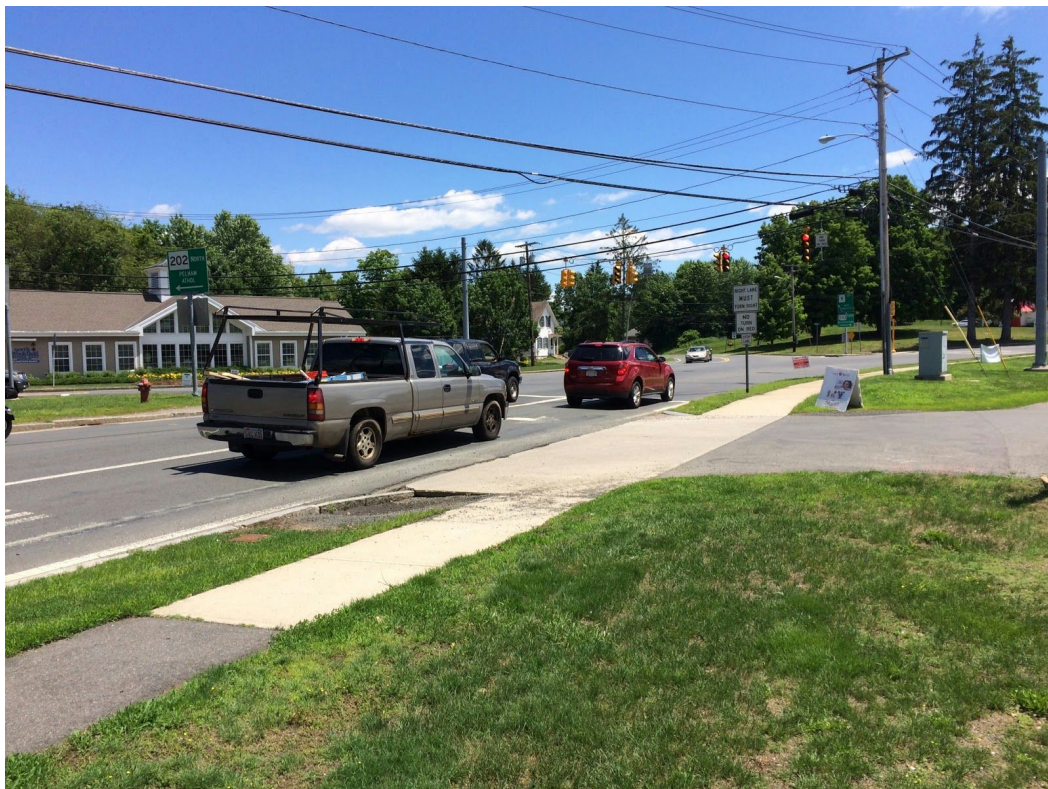
N Approaching the Route 9/Route 202 intersection from Route 9, heading East.

The sidewalk on the south side of Route 9 continues through the intersection until it stops at the entrance to the shopping plaza. At this point, pedestrians are supposed to cross at the pedestrian light and continue on to the other side where the sidewalk picks up. In order to reach the other side, pedestrians must also cross a slip lane which has no signal. There is a sign warning that pedestrians may cross, but it is hidden by a tree. The pedestrian traffic signal crossing phase was adequate for the participants, but there was no countdown clock and no audio signal for people who are visually impaired.

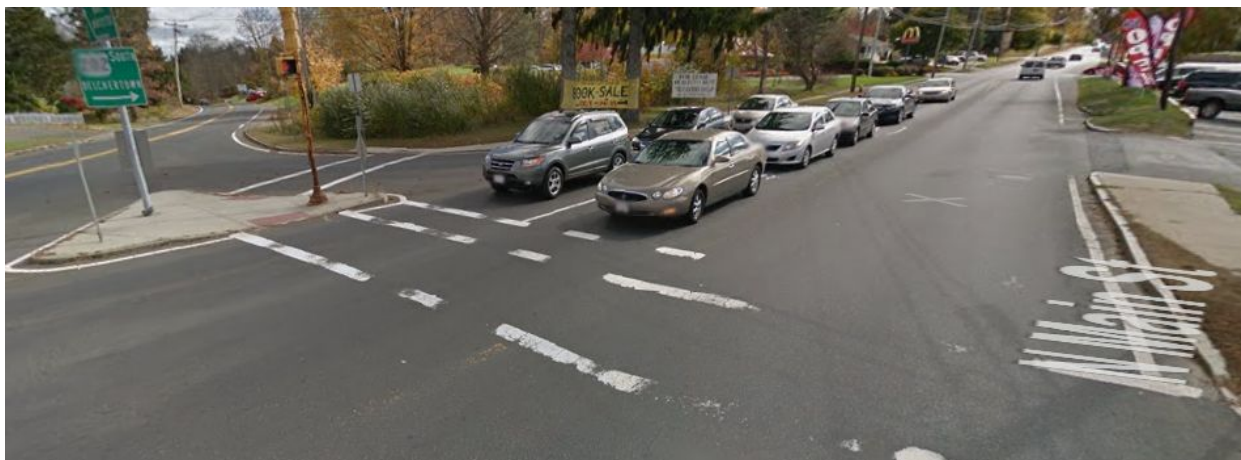
N Pedestrian crosswalk and signal at Route 202 S

There are crosswalks painted in the parallel line style over this part of the intersection (note: the parallel lines have recently been updated with new paint). Recently, a “no turn on red” rule was instituted for cars heading from Federal Street turning right onto N. Main St. There are no other pedestrian accommodations within this intersection, so pedestrians cannot safely travel across any of the other lanes. There are no bicycle facilities. There are some street lights throughout this study area.

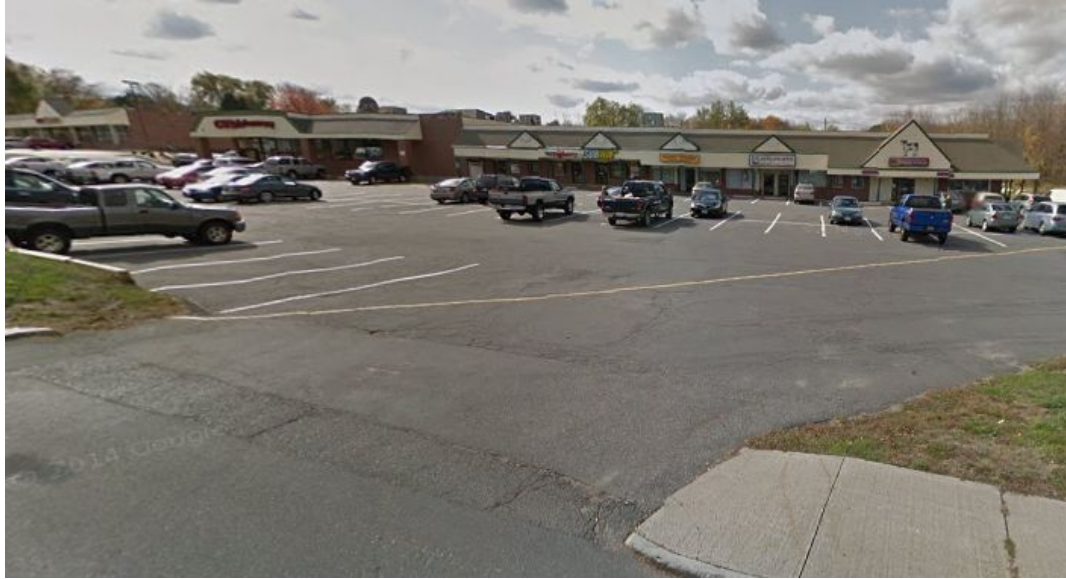
Parking lot of the shopping plaza

For pedestrians attempting to do shopping by foot, it is not clear how they are expected to negotiate the Crystal Springs Plaza parking lot. The sidewalk ends on one side of the curb cut and doesn't pick up on the other side. There are no walking paths or markings indicating the route that a pedestrian should take to walk through the parking lot safely.

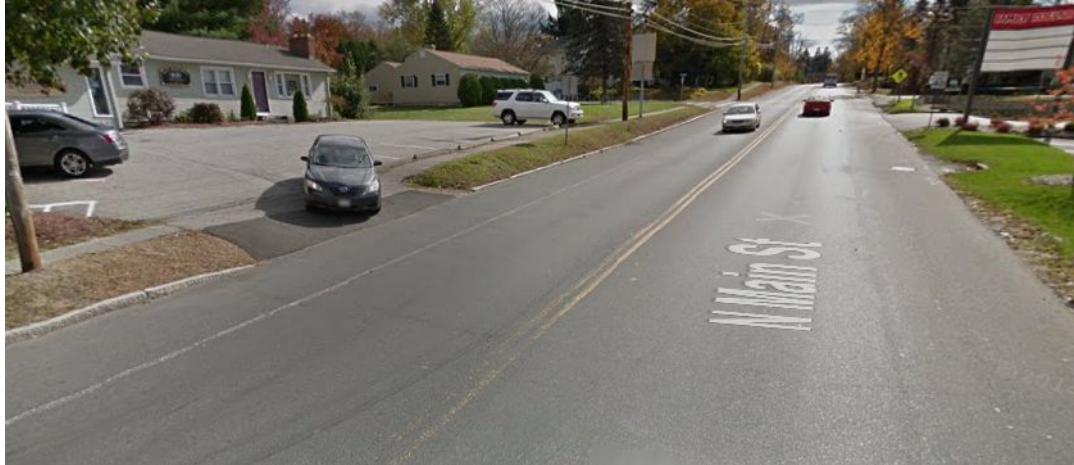
N. Main St. heading south on Route 202

Beyond the intersection following N. Main Street (Route 202), the sidewalk continues up the east side and crosses several curb cuts. In some cases, the sidewalk material is consistent across the curb cut (such as the one pictured above), making it safer for pedestrians. There is a grassy buffer between the sidewalk and the road. The sidewalk itself is narrow and uneven. There was garbage blocking the sidewalk at 133 N. Main Street, in front of Belchertown Optical. In this vicinity of sidewalk there is a deep eroded depression that could be a tripping hazard.

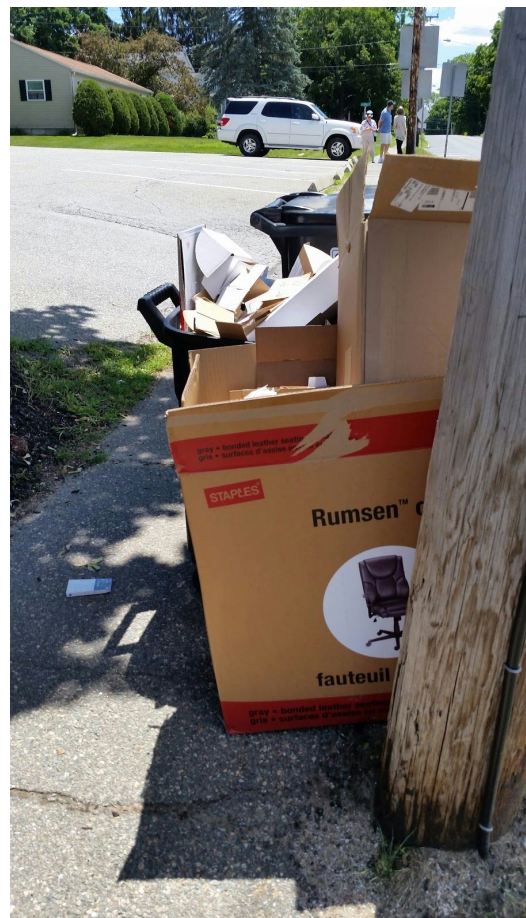
Garbage blocking sidewalk outside of Belchertown Optical

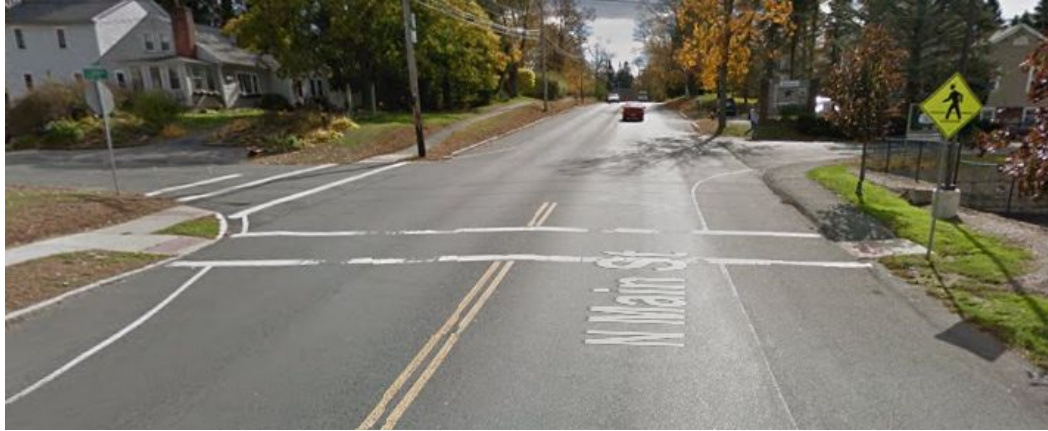
N Crosswalk at Lloyd Ave and driveway to the Lord Jeffrey Apartments **S**

Continuing on N. Main Street, there is a parallel line-style faded crosswalk at Lloyd Ave. There are also curb ramps and detectable warning strips and a pedestrian crossing sign. The pedestrian sign was partially obscured by the tree. There is a 40 MPH speed limit sign just before the pedestrian sign. Across from Lloyd Ave is the driveway for the Lord Jeffrey Apartments. Cars were slow to yield to walk audit participants trying to cross here. We spoke to a woman and her child who try to cross here frequently and they said it is difficult to cross because cars do not stop. Participants wondered whether a wheelchair could safely make the sharp left turn onto the sidewalk coming from the crosswalk on the south side.

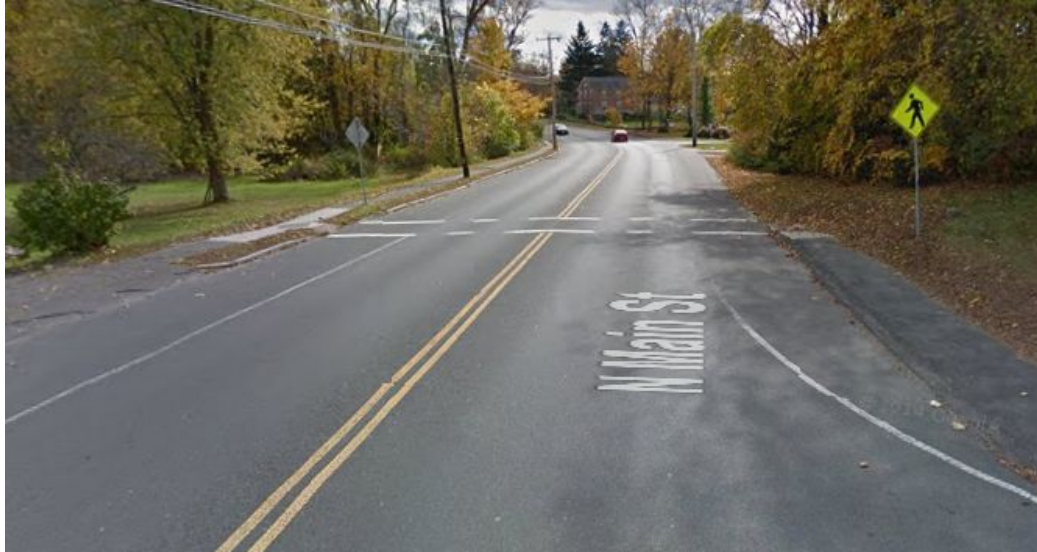
Crosswalk at Tucker Lane

People living on Tucker Lane who want to walk to the shopping plaza must cross at this crosswalk since there is no sidewalk on the side of Tucker Lane. They must cross back at Lloyd Ave or the Route 9/202 intersection to enter the shopping plaza. The pedestrian sign pictured here (from google maps) is partially obscured by a tree. Participants reported difficulty in seeing traffic coming from the north from the Tucker Lane side of the road.
